**Purley Leisure Centre, Croydon****Asset Register**

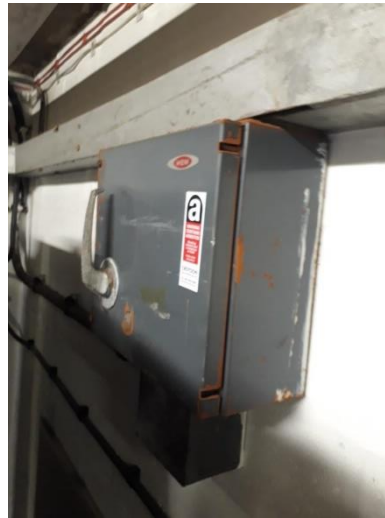
**G.E.109**

**MEM isolator 100A x 1**

**Grade C**

**Medium Corrosion to isolator housing**

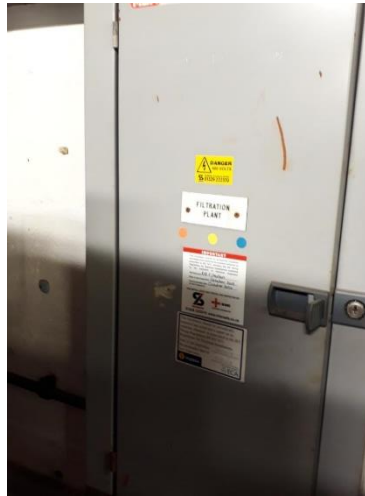
Asset Reference: **G.E.110** Inspection Date: **14.03.19**

Equipment / Plant Ref: **Filtration plant distribution board x 1**  
 Model Type:   
 Quantity: **No.**  
 Manufacturer: **MEM**  
 Serial No: **Not available**

Condition Rating: **Grade B**  
 See section 1.4.1 for grading details

Comments: **Medium corrosion to DB housing.  
 Period inspection expired 03.01.2019  
 Not lockable.**

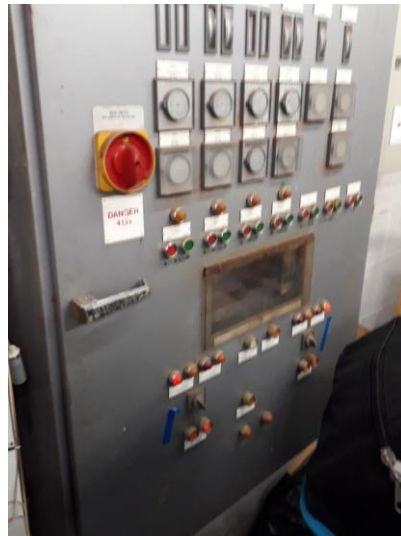
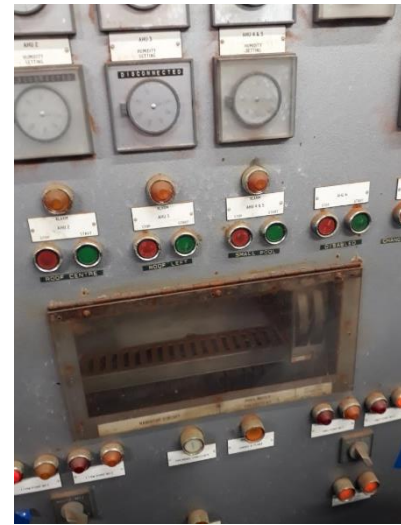
Asset Reference: **G.E.115** Inspection Date: **14.03.19**

Equipment / Plant Ref: **Main TPN ventilation control panel x 1**  
 Model Type:   
 Quantity: **No.**  
 Manufacturer: **Main Systems**  
 Serial No: **Not available**

Condition Rating: **Grade C**  
 See section 1.4.1 for grading details

Comments: **Heavy Corrosion to control panel housing**

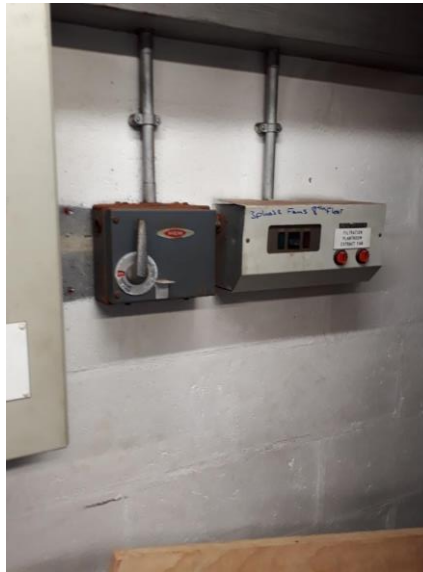
Asset Reference: **G.E.116** Inspection Date: **14.03.19**

Equipment / Plant Ref: **MEM 20 amp isolator to filtration room extract fan x 1**  
 Model Type:  
 Quantity: **No.**  
 Manufacturer: **MEM**  
 Serial No: **Not available**

Condition Rating: **Grade C**  
 See section 1.4.1 for grading details

Comments: **Heavy Corrosion to isolator housing**

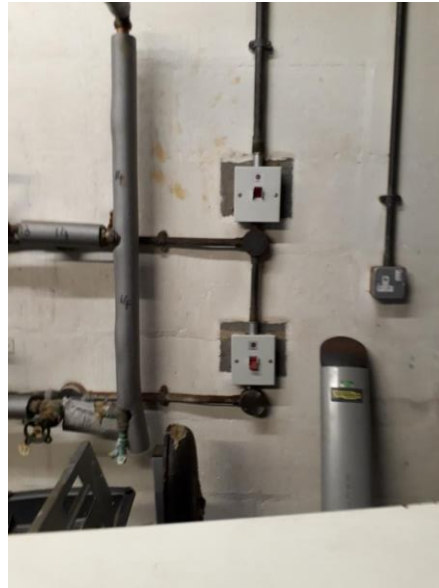
**G.E.117**

**MEM isolation to HWS pumps 20A x 2**

**Grade A**

**Replaced in recent years.**

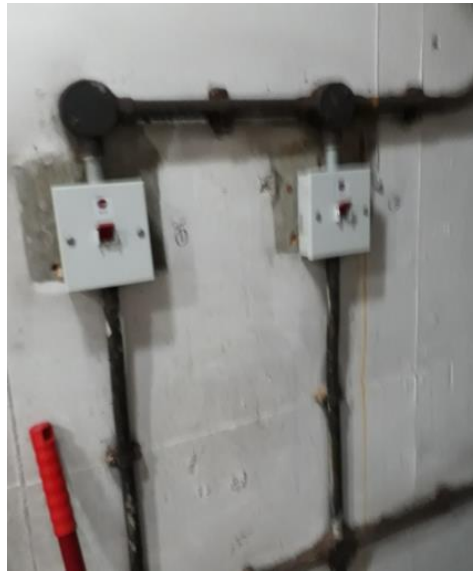
**G.E.132**

**Pump isolator 20 amp x 2**

**Grade A**

**Replaced in recent years.**

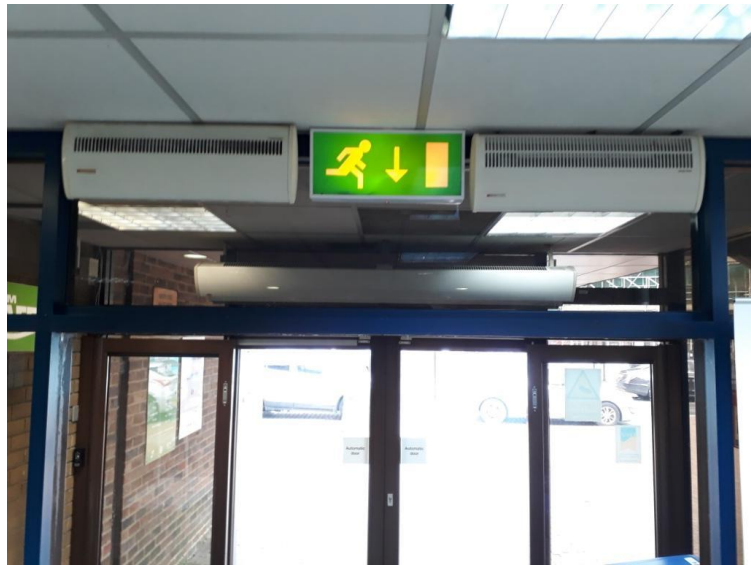
**G.E.19**

**Blow heaters x 2**

**Grade B**

**Condition of the heaters are satisfactory and fair for their age.**

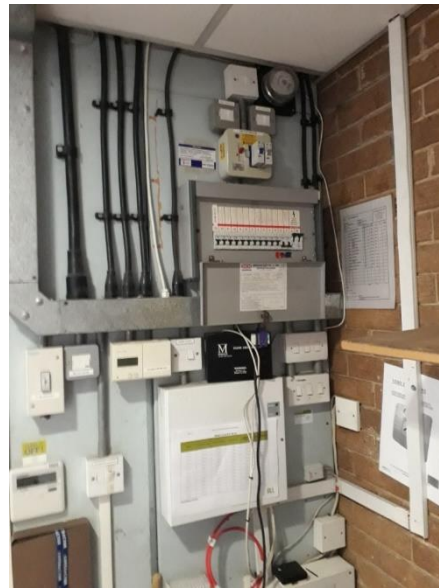
**G.E.20**

**Elec dist board x 1**

**Grade B**

**Satisfactory install but bad operational practice.****This board is used to switch lighting circuits on and off rather than using local switches. Suggest this is reviewed ASAP.**

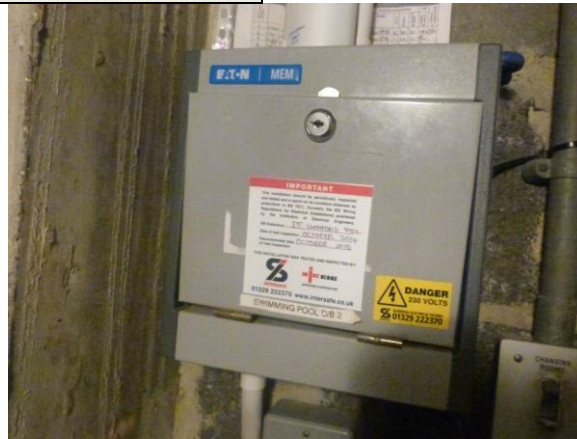
**1.E.79**

**Distribution board x 2 DB 1 Changing romm DB2 Swimming Pool**

**Grade A**

**DB's added during pool hall lighting refurb, satisfactory**

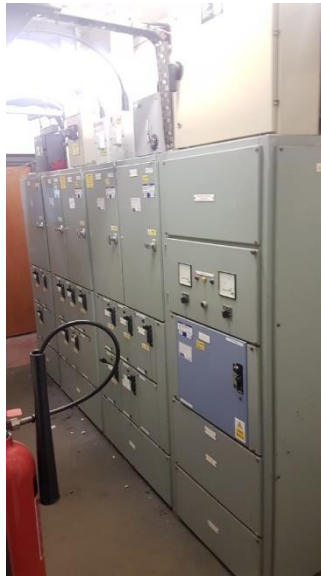
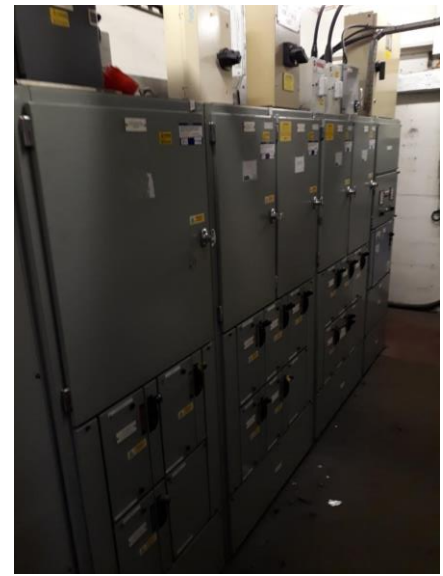
**2.E.10**

Electrical incoming position &amp; main isolator x 1

**Grade B**

**MCCB's within boards in the switchgear obsolete**

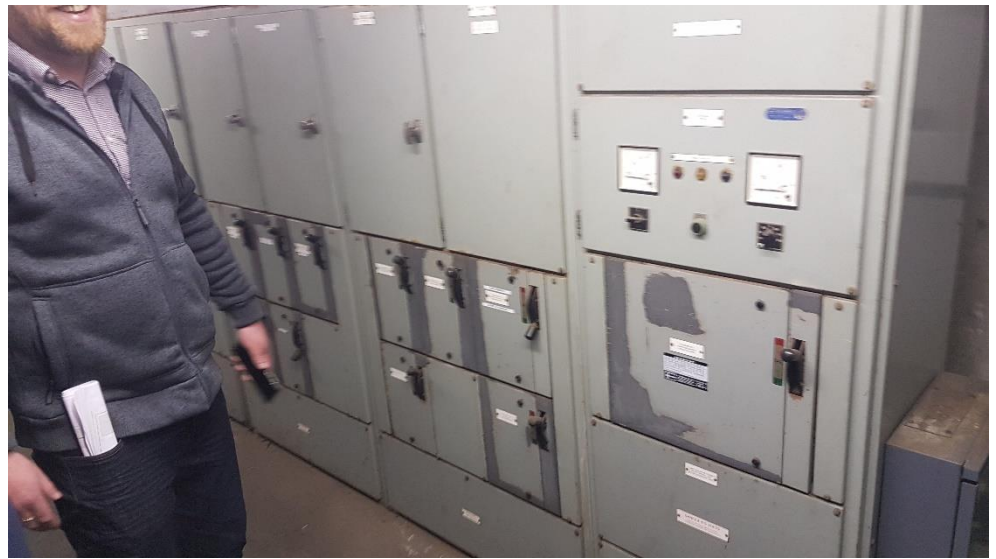
**2.E.11**

Electrical distribution system – CARPARK Board

**Grade B**

**MCCB's within boards in the switchgear obsolete**

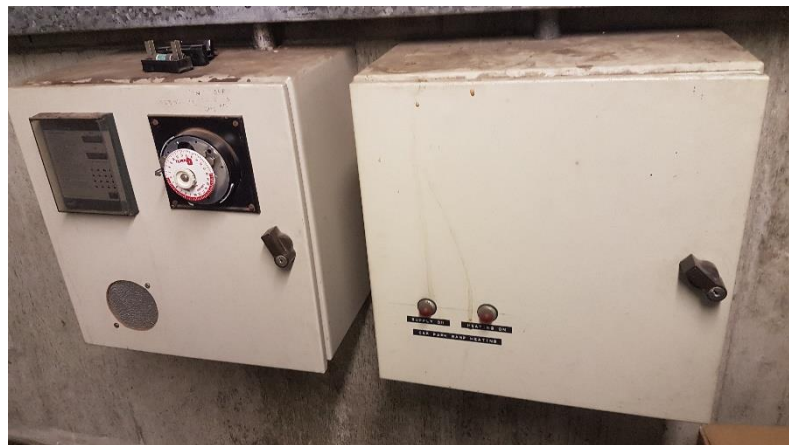
**2.E.7**

**Lighting time control & heating panel x 1 - CARPARK**

**Grade B**

**Satisfactory for its age.**

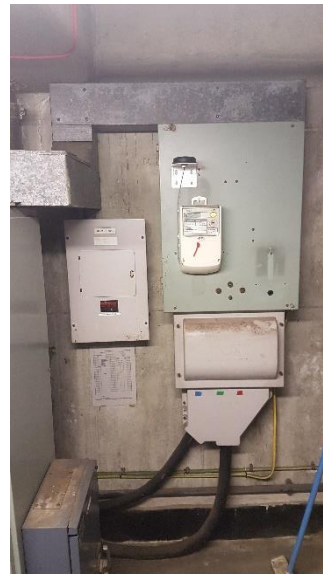
**2.E.8**

**Car park pay machines distribution board x 1 - CARPARK**

**Grade B****See section 1.4.1 for grading details**

**MCCB's within board obsolete**
